Contractor:  
Varian Associates  
611 Hansen Way  
Palo Alto, Ca. 94303

QUARTERLY TECHNICAL REPORT NO. 3

1.06-Micron Image Intensifier Tube Development

(October-December 1972)

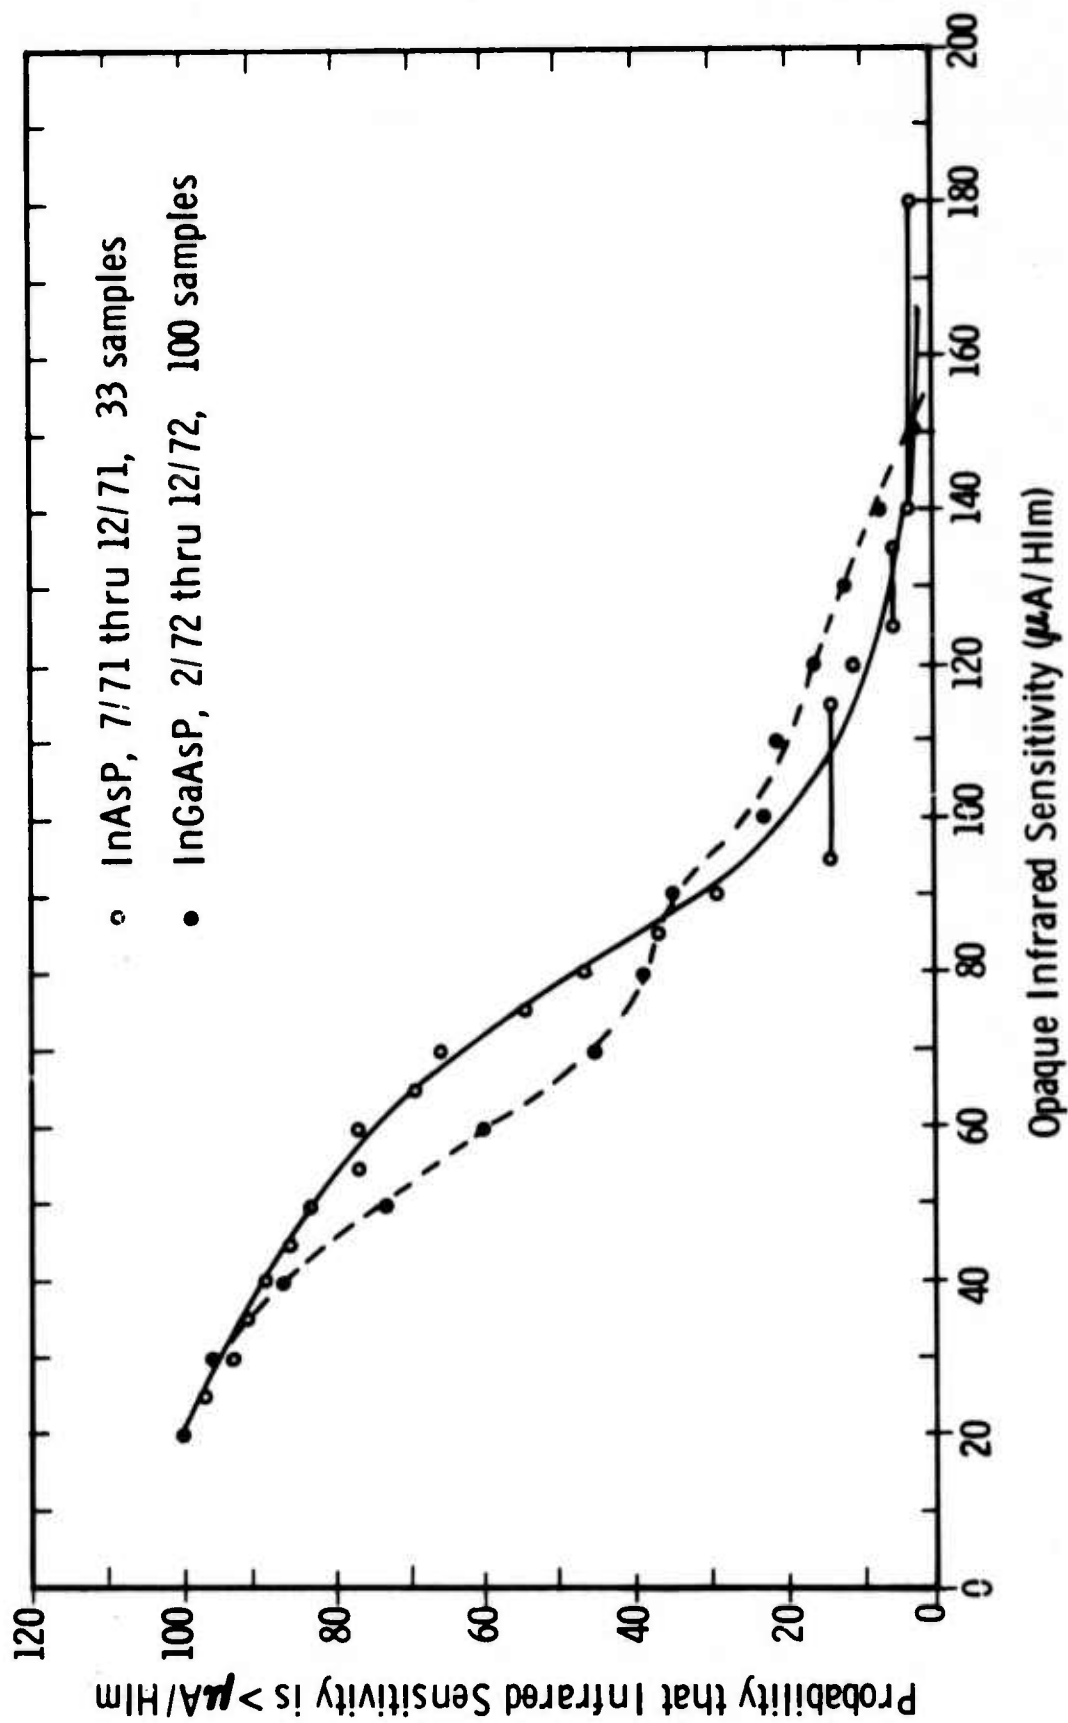
Figure 1. Probability distribution for the opaque infrared sensitivity obtained from InAsP and InGaAsP.

An opaque infrared sensitivity probability distribution for InAsP and InGaAsP photocathodes is presented in Fig. 1; these data were obtained prior to the completion of the new growth facility solely for the purpose of growing InGaAsP cathodes for image tubes. The first cathodes grown in the new facility had very low yields. After considerable testing the low sensitivities have been found to be due to over-doping of the epitaxial layer. The doping of the cathode is established by adding a small amount of zinc to the melt prior to each growth; the amount of Zn to be added having been rather crudely determined some time ago. A comparison of the sensitivities obtained, using the same procedure for adding Zn prior to each run, in the two facilities is shown in Fig. 2. On reducing the amount of Zn added to the melt prior to the first growth a rather critical optimum, Fig. 3, was observed. Prior to this effort the amount of Zn necessary to achieve optimum sensitivity on the first growth of a new melt was never formally established. At this time a complete procedure for adding Zn has not been determined, but should be in a week or two, and a better probability distribution than shown in Fig. 1 should result.

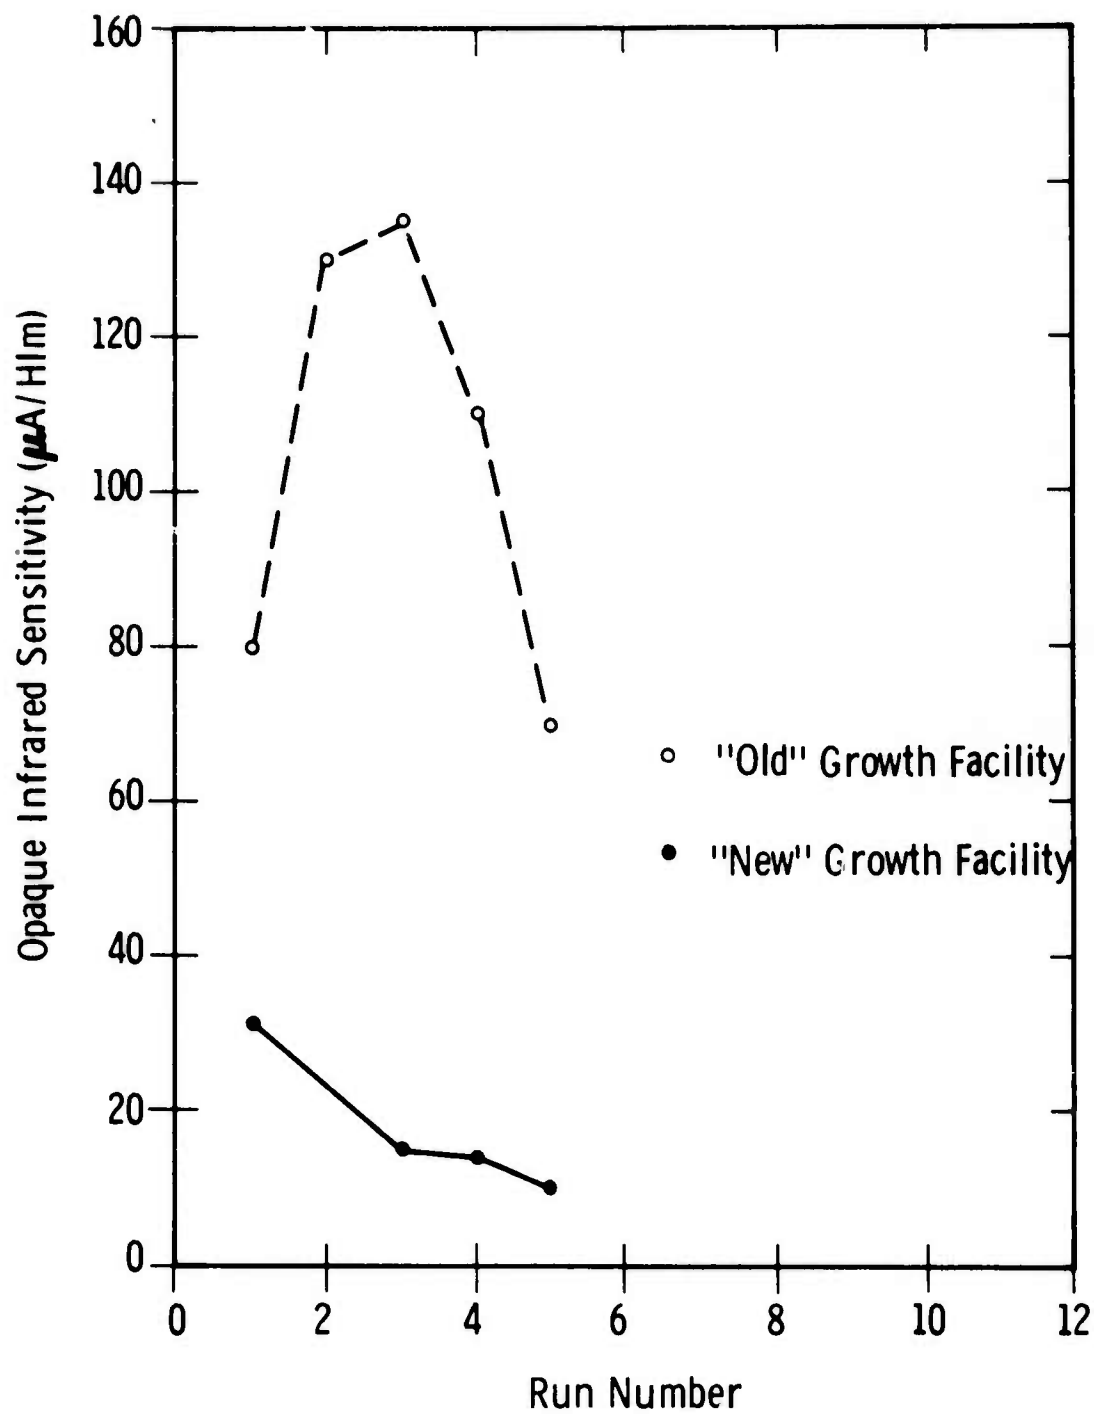
Figure 2. Infrared sensitivity vs run number for two growth facilities using the same melt composition and doping procedure.

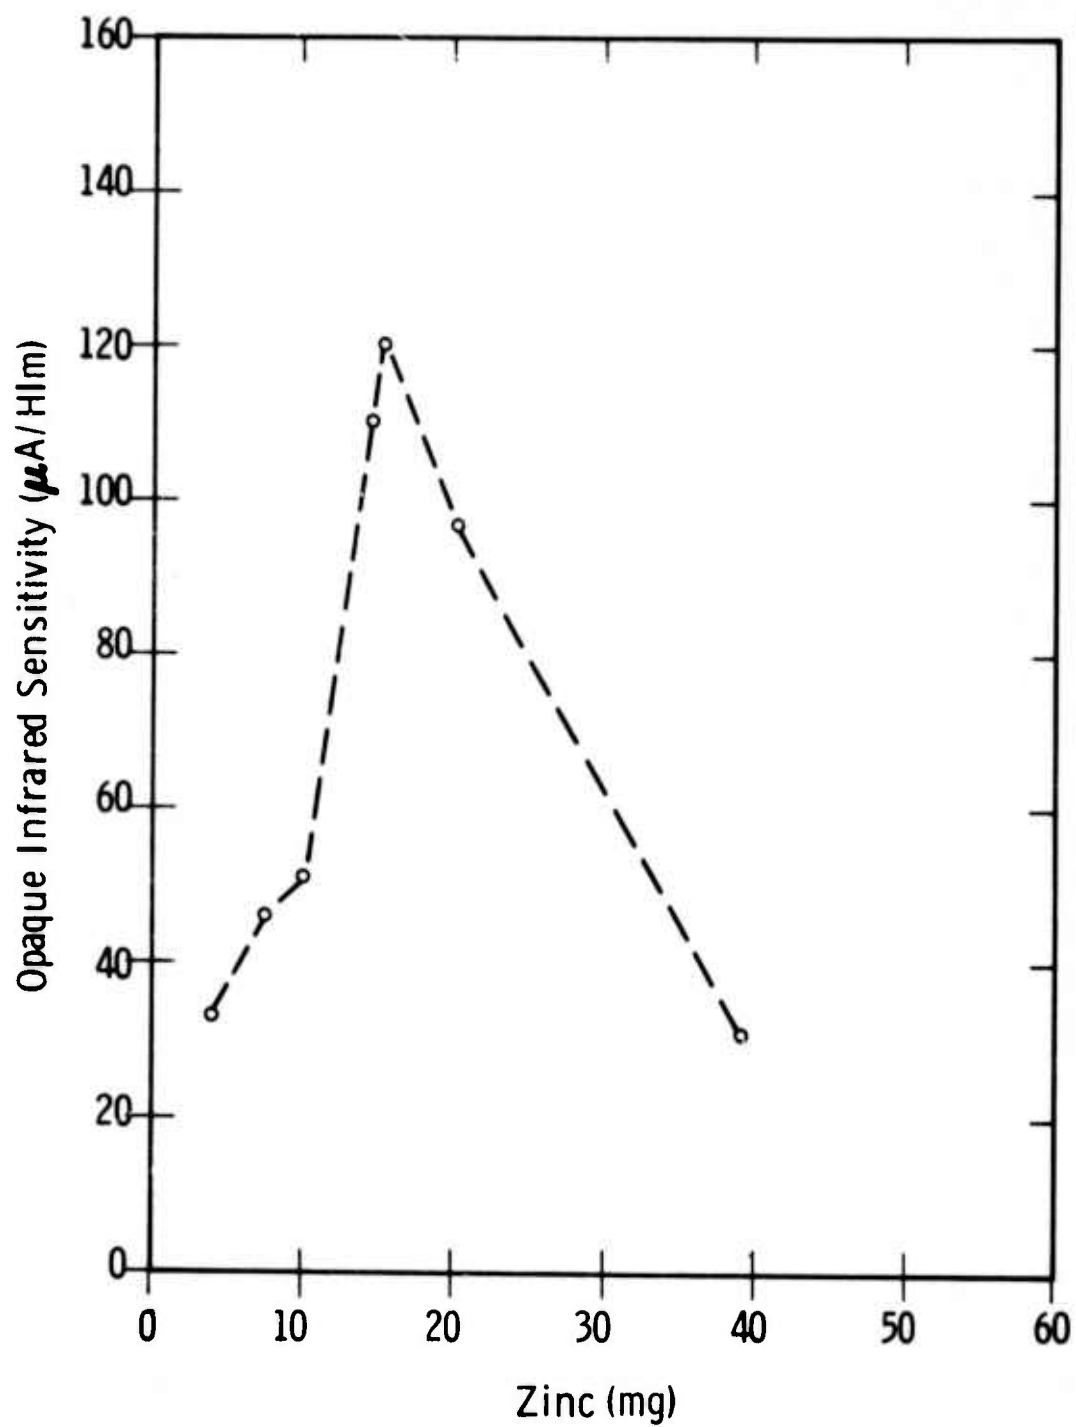
Figure 3. Opaque infrared sensitivity vs the amount of Zn added to the melt prior to the first growth.

The reason for the gross change in the amount of Zn now required (about a factor of two less) is believed to be due to improving the purity of the hydrogen source, possibly the primary Zn loss mechanism being due to a contaminant in the hydrogen

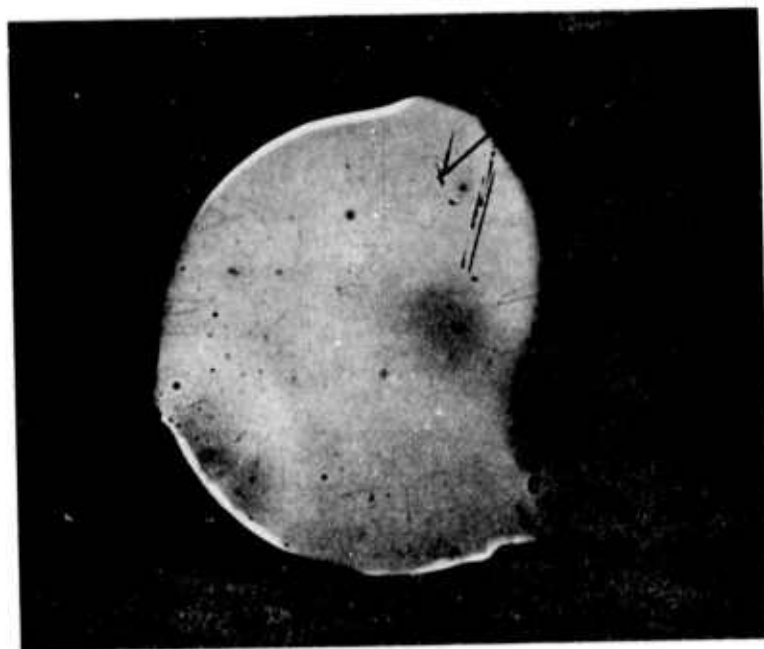
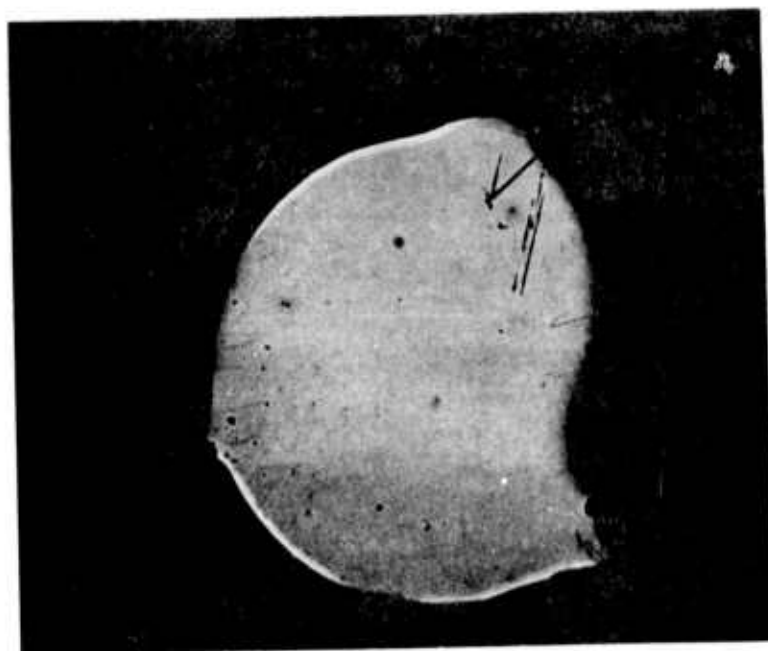
(a) 1.0 Micron  
Semitransparent  
Illumination

(b) 1.0 Micron  
Opaque  
Illumination

Figure 4. Photographs of the Output Image of INV #56 With Uniform Input Illumination

(4) Defects which are believed to be at the interface and appear as gray, roughly circular blemishes with semitransparent illumination only, see Fig. 5. These are due to some, as yet undetermined, variation in the details of the growth procedure because only about one-third of the cathodes are observed to have this type of cosmetic problem. Note, for example, that this defect is not observed in Fig. 4.

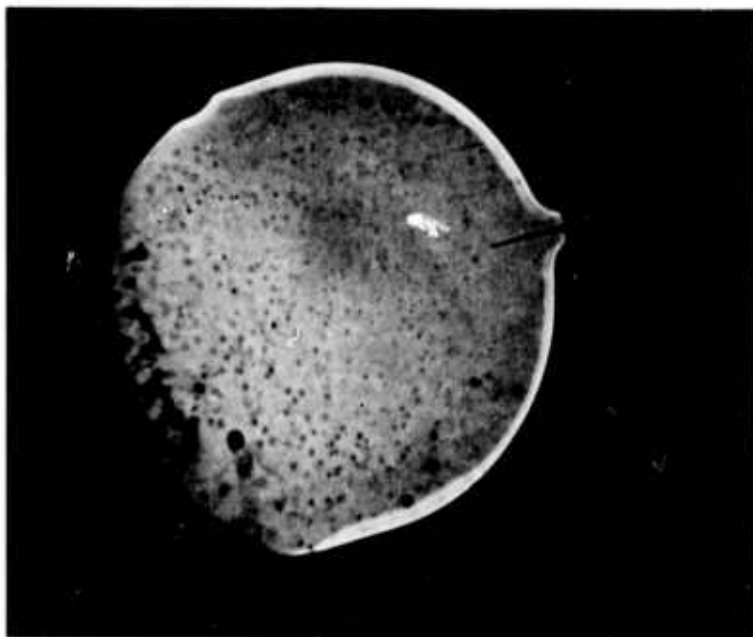
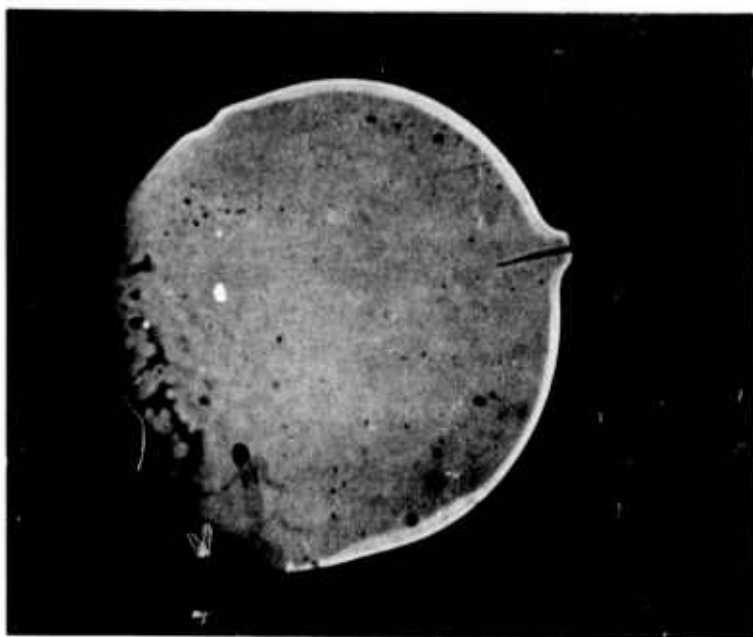
(a) 1.0 Micron  
Semitransparent  
Illumination

(b) 1.0 Micron  
Opaque  
Illumination

Figure 5. Photographs of the Output Image of INV #58  
With Uniform Input Illumination

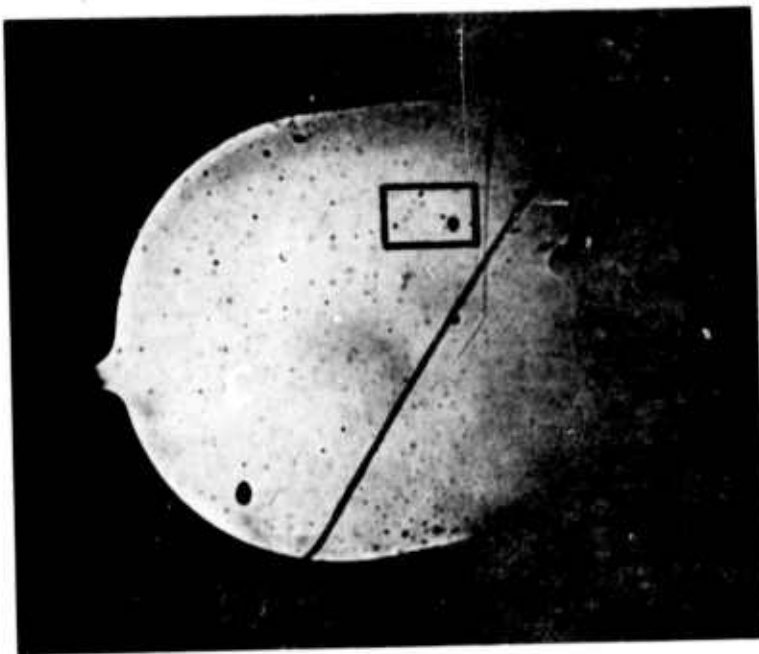
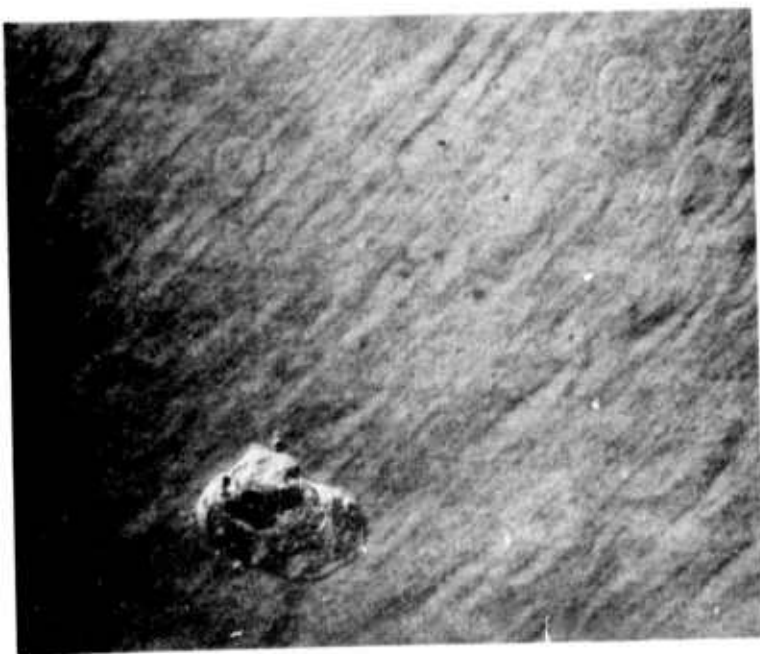
Figure 6.

(5) Finally, the very black blemishes; these result from at least two problems, both of which are made apparent with the aid of Fig. 6. Figure 6(a) is the usual semitransparent photograph of a cathode in an image tube. Figure 6(b) is a micrograph of the region of the cathode outlined in Fig. 6(a) obtained after the cathode was removed from the tube. The large black

(a) Photograph of the Output of  
INV #54 With Uniform Input  
Illumination

(b) Microphotograph (50X) of  
the Area Outlined in (a)

blemish is due to melt which was not removed from the cathode after growth. The smaller blemishes, six of which are visible in the right-half of Fig. 6(b), are particles believed to be chips from the edge of the cathode broken off during transfer to the image tube. These particles were removed quite easily by ultrasonic agitation in a dilute Alconox solution. Methods are under investigation to more effectively remove the melt and minimize the number of particles bound to the surface.

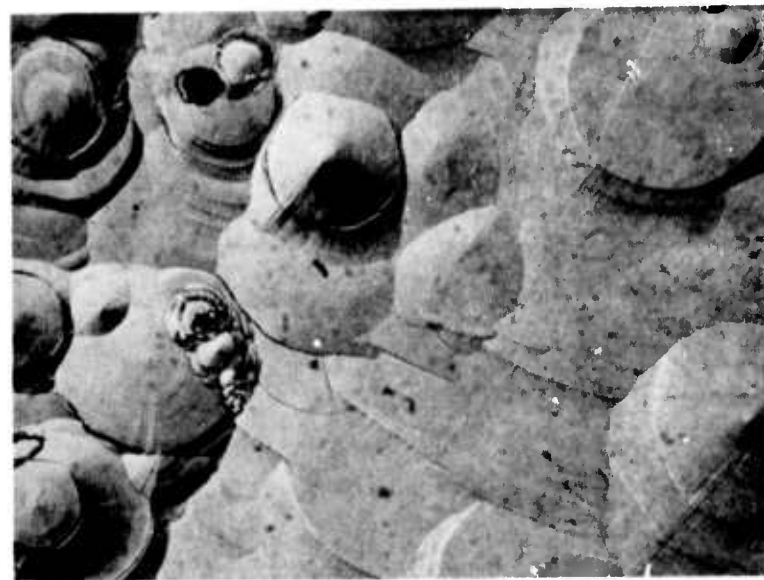
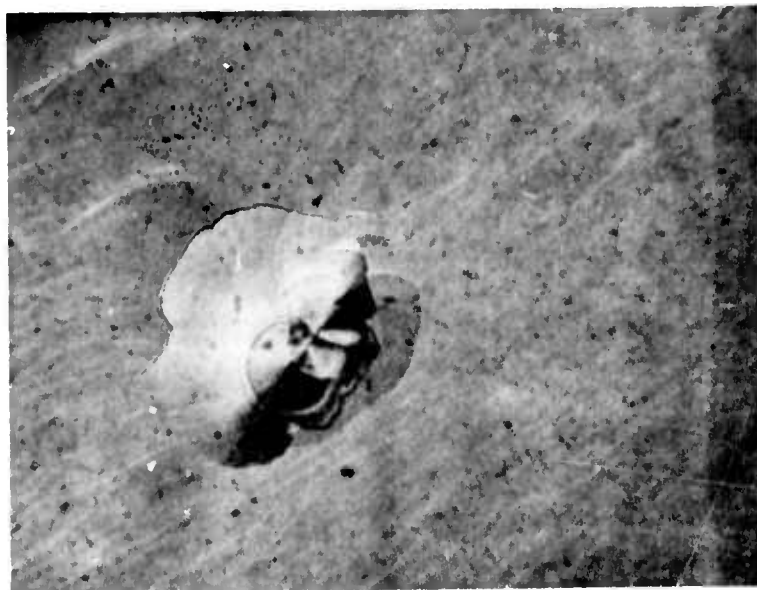
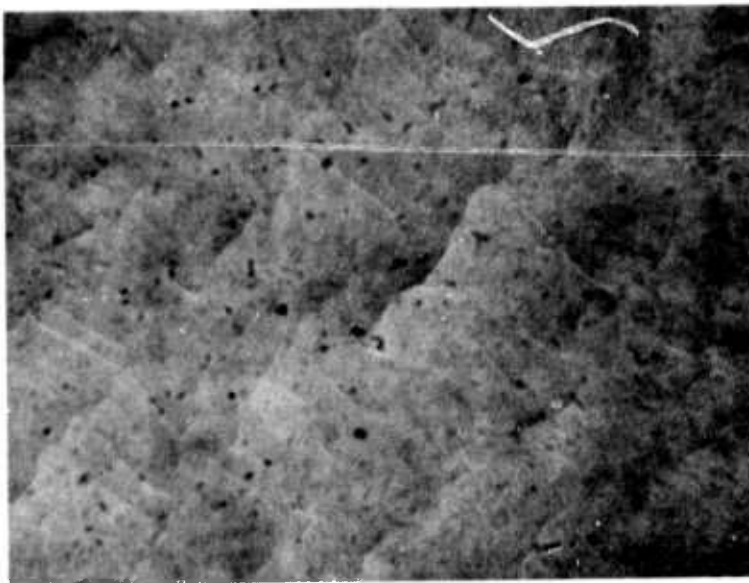
(a) 600°C

(b) 650°C

(c) 700°C

Figure 7. Microphotographs (50X) of InGaAsP Layers Grown at Three Different Temperatures

2.1.2.3 Quaternary Surface Texture Dependence on Growth Temperature. It is well known that the surface defect density is a function of the substrate quality. It has been observed, however, that it is an even stronger function of the growth temperature. (For a defect-free substrate, one would expect no dependence of the surface texture on growth temperature.) Our layers are grown at 650°C; however, when the growth originates at 600°C we observe a marked increase of the surface defect density; conversely, growth at 700°C results in practically mirror-smooth surfaces. Growth at higher temperatures involves other problems, such as control of the liquid composition due to the volatility of the components. This, however, is not considered a serious problem. At present we are investigating the growth of InGaAsP at 700°C lattice-matched to InP.

The effect of the growth temperature on defect density can be seen in the Fig. 7(a,b,c) series of microphotographs.

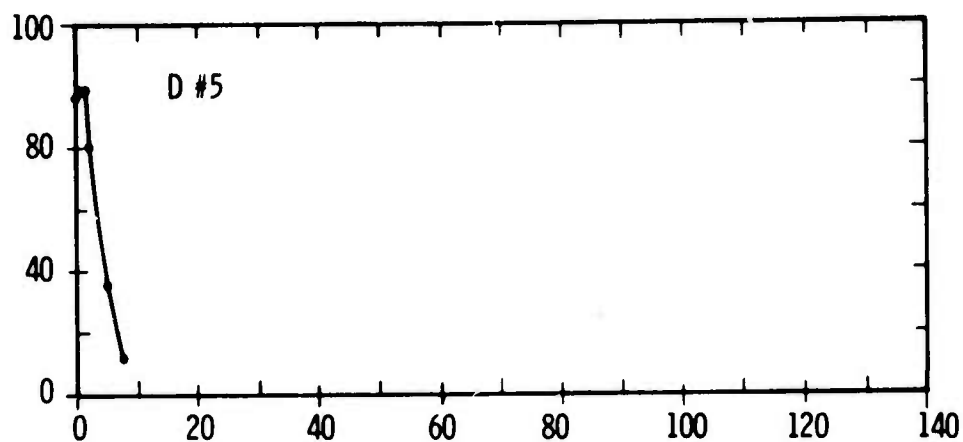
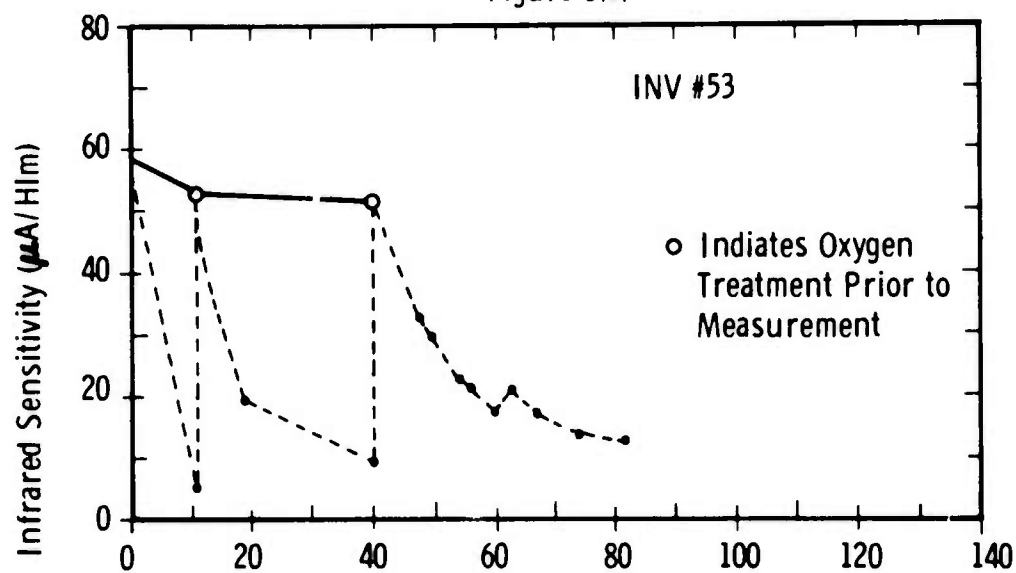
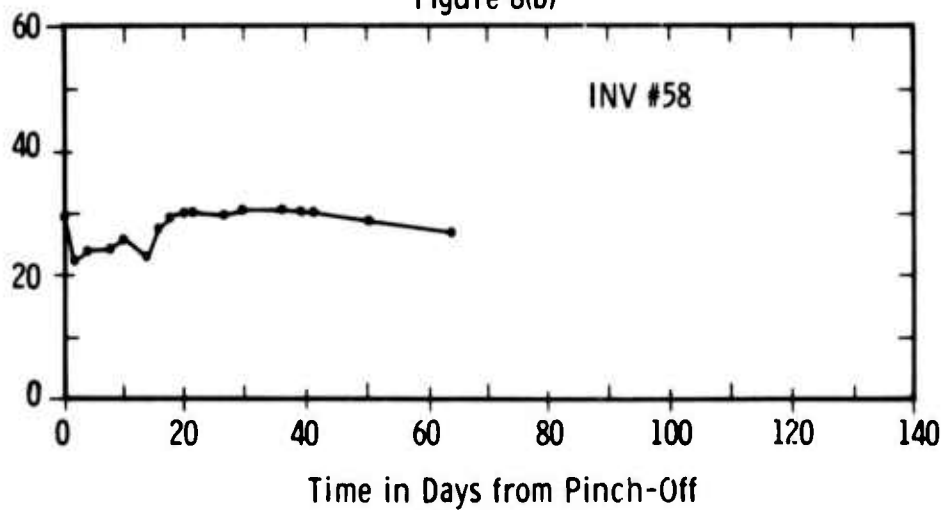
Figure 8. Shelf life of three tubes illustrating slump.

in devices the typical shelf life was that of D#5, Fig. 8(a). This degradation was irreversible in that the sensitivity could not be restored with Cs and/or oxygen. With the development of the EPIC process now used to fabricate image tubes the shelf life was improved, taking the form of a reversible decrease or slump (Fig. 9), periodic oxygen treatments being required to maintain the high sensitivity. Improvements in the precesiation of the tube and the activation geometry resulted in better shelf life, fewer oxygen treatments being required, as shown in Fig. 8(b).

One tube sealed off during the quarter, INV#58, exhibits the best stability observed to date--see Fig. 8(c). No oxygen treatments have been administered to this tube in the 60 days since pinch-off. Three things were slightly different in the fabrication of INV#58. First, the oxygen inlet to the pre-processor was modified to eliminate the black shade (see Sec. 2.1.2.1). Second, a 100°C bakeout was inserted into the processing after the precesiation of the tube to, hopefully, more uniformly distribute Cs in the tube envelope. Several tubes have been made since INV#58 with these two modifications however, and none have the stability of INV#58. Third, due to an error in the tube assembly the spring which holds the cathode in the tube was poorly aligned and the cathode is extremely loose, essentially only lying on the input window. Although it seems like a very remote possibility that spring tension could cause the slump, an experiment is planned to test the effect stress has on the yield of the quaternary.\* The mere fact that the procedures used to fabricate 1.06-micron sensitive image tubes produced a tube with the stability of INV#58 seems to indicate that a solution to the slumpage problem is quite near.

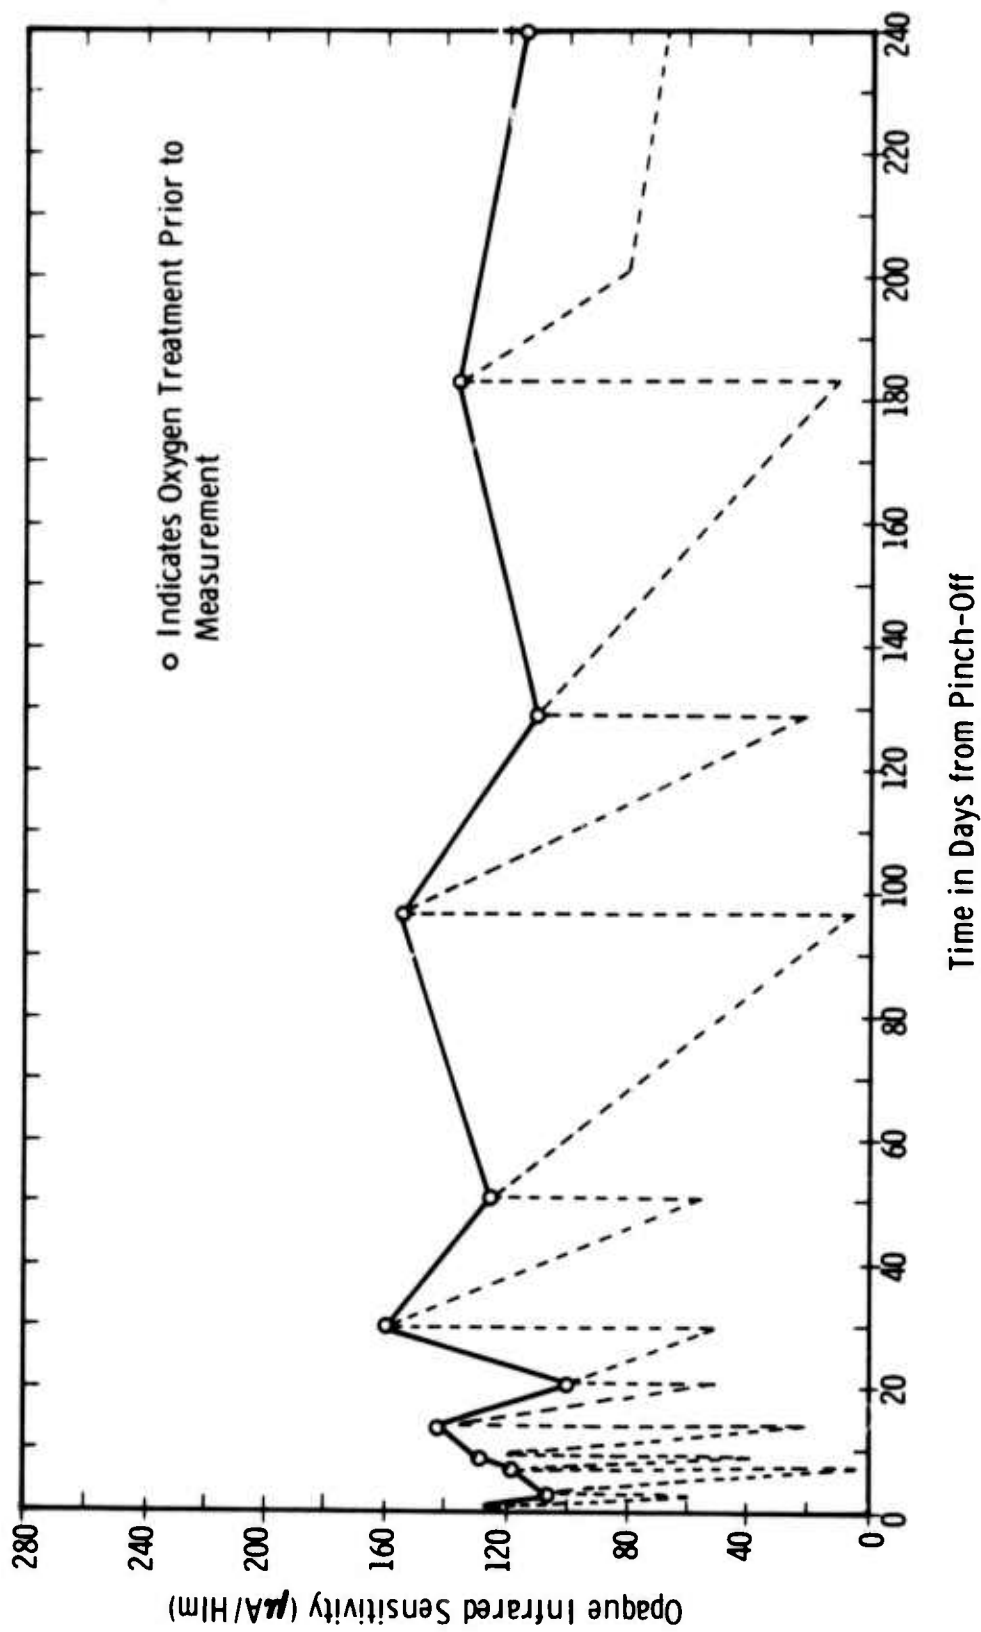
Figure 9. Detailed shelf life of D#18.

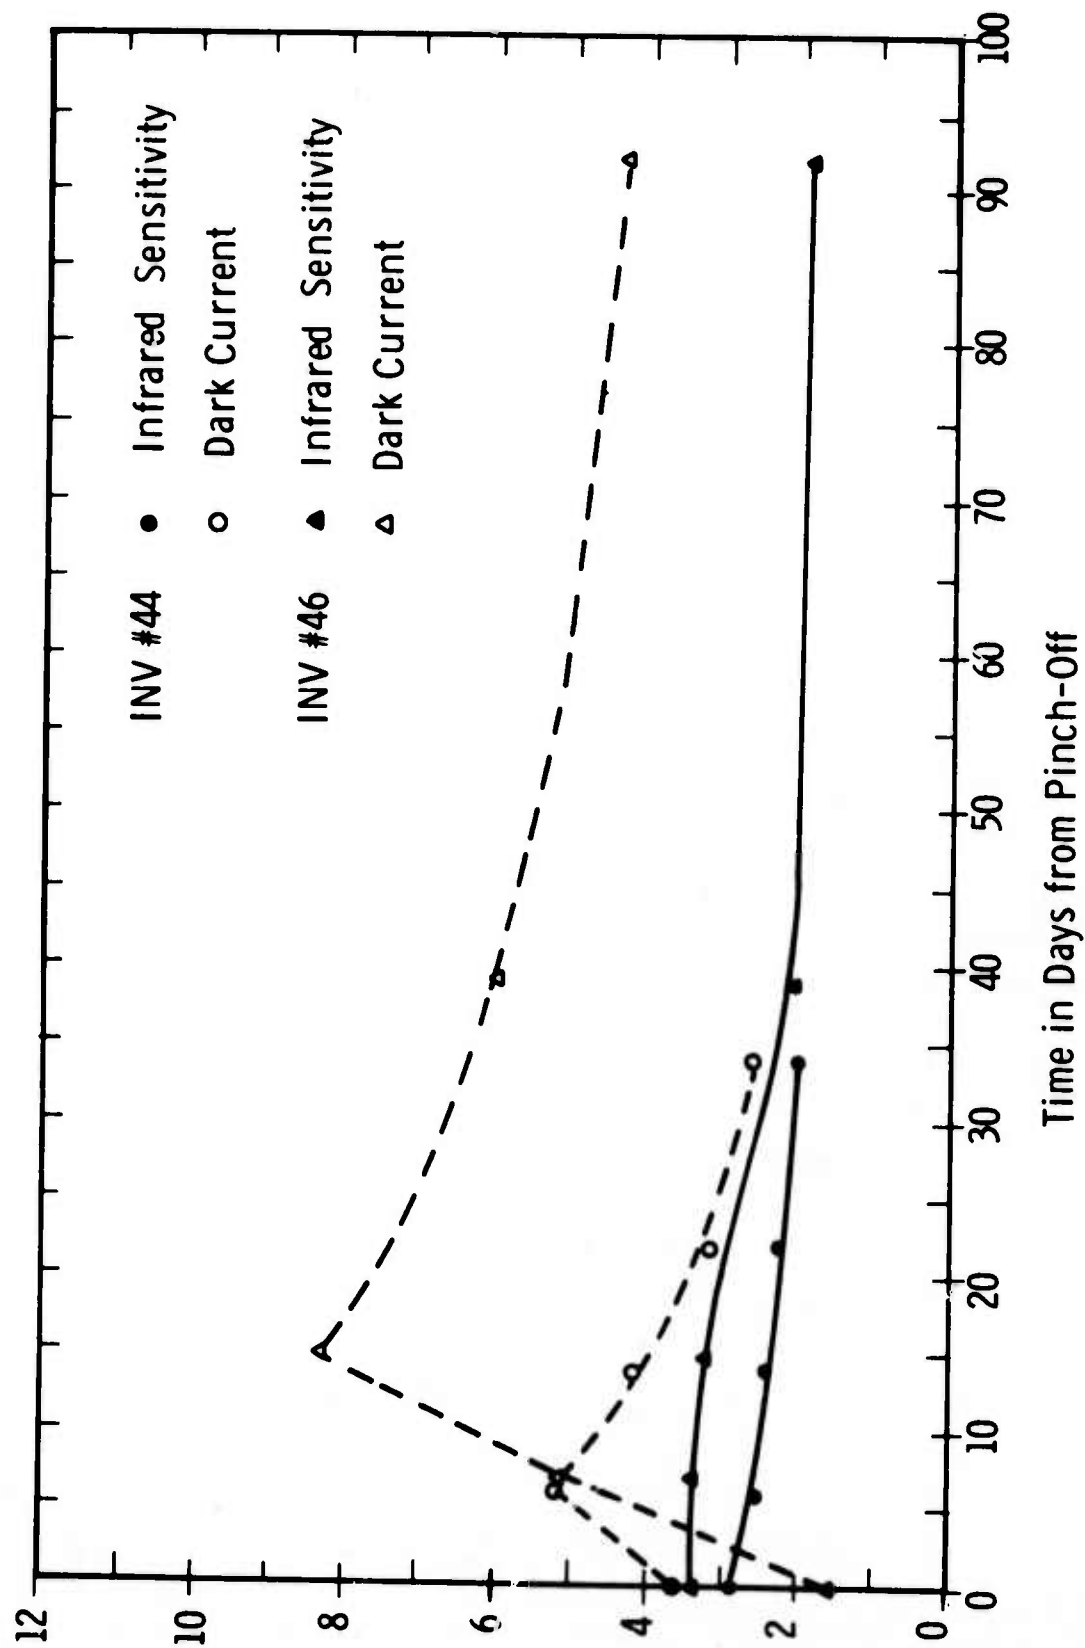
Figure 10. Infrared sensitivity and dark current as a function of time from pinch-off. Cathode peaked with oxygen prior to making measurements.

(2) The sensitivity and dark current change in a reasonably predictable manner with successive oxygen treatments (Fig. 10). It seems impossible to explain the loss in sensitivity as simply due to an increase in Cs-oxide thickness since the dark current would have to increase by a factor  $\geq 10$  (see Fig. 13 of Quarterly Report No. 2) and this is not observed.\*

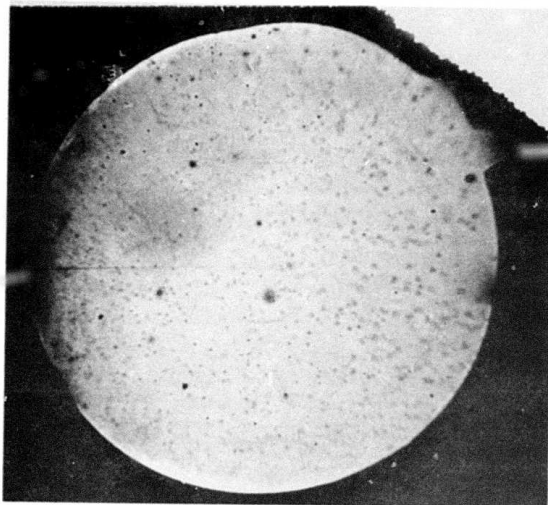
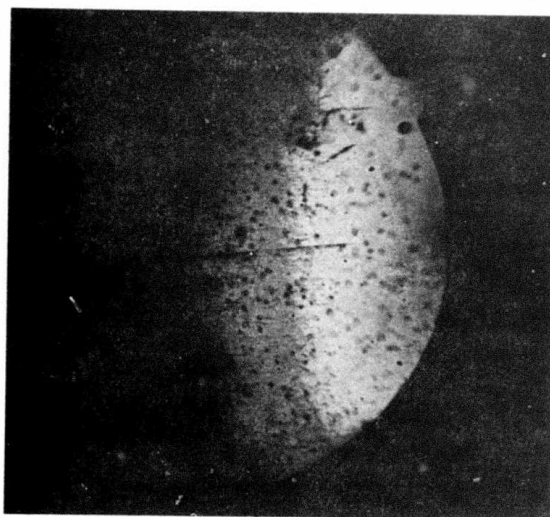
(a) Just After Pinch-off

(b) Three Days After Pinch-off

Figure 11. Photographs of the Output Image of INV #57 With Uniform Input Illumination

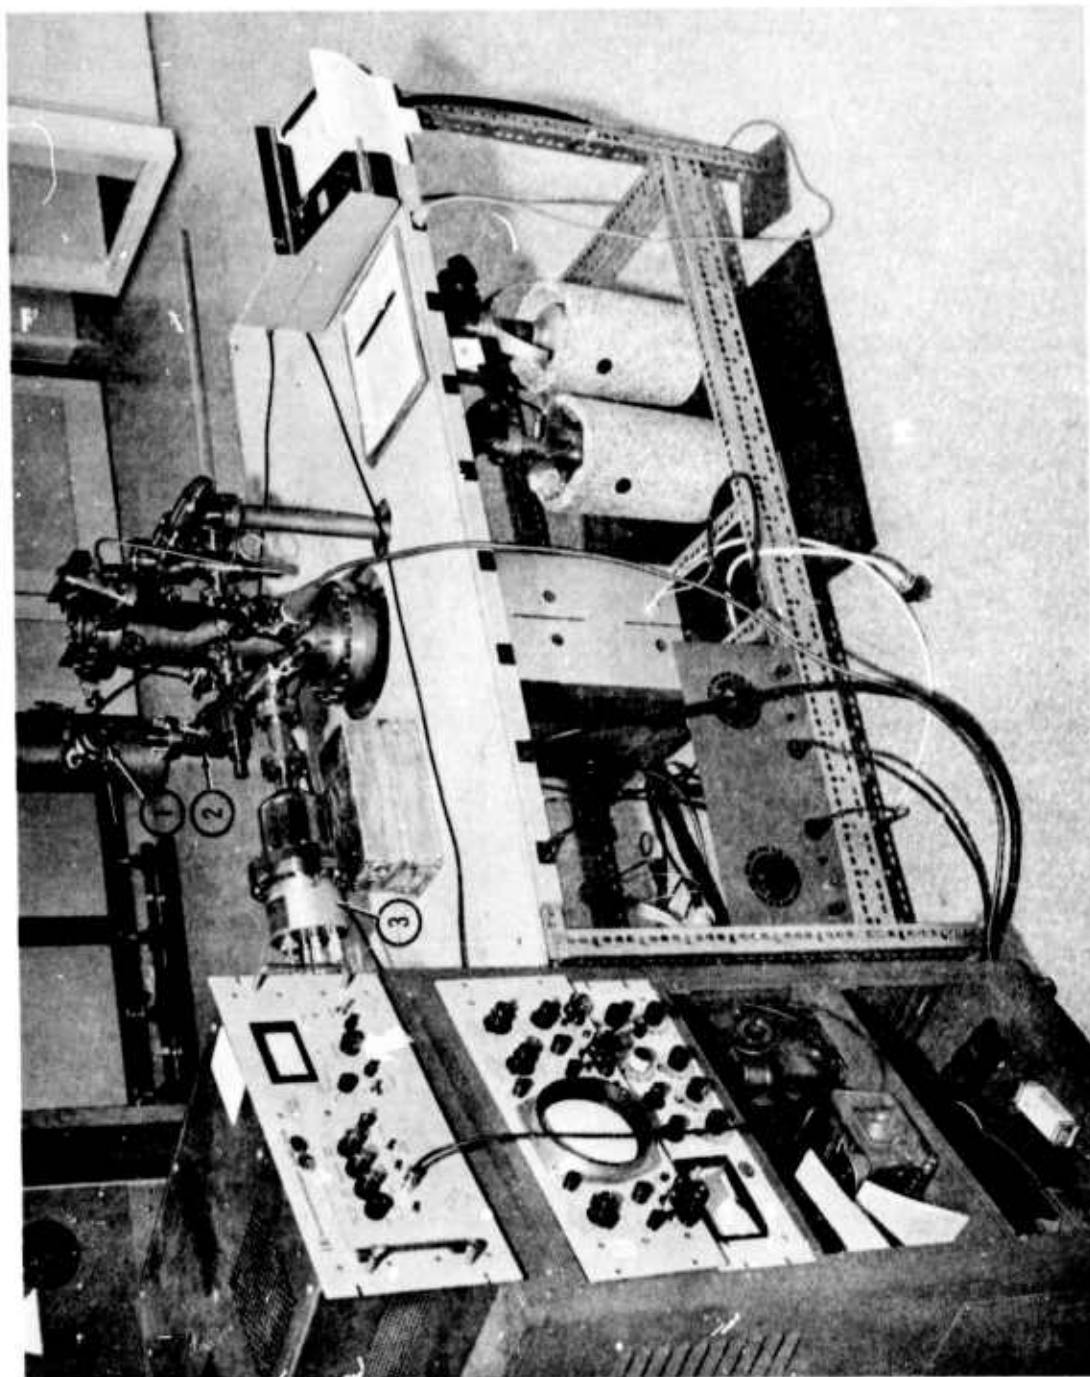
Figure 12. Photograph of the Flash-Filament Experimental Setup.  
(1) Standard inverter tube containing filament.  
(2) Valve for isolating the tube from the vacuum system.  
(3) Quadrupole residual gas analyzer.

2.1.3.2 Long-Term Gas Evaluation in III-V Tubes. With the hope of shedding some light on the slumpage problem as well as the long-term shelf life, a flash-filament experiment has been initiated. This experiment (see the photograph in Fig. 12) consists of a standard inverter tube envelope in which is mounted a tungsten filament, a quadrupole residual gas analyzer (RGA) mounted close to the tube, and a valve for isolating the tube from the vacuum system and RGA. The tube was baked and outgassed in the usual manner and data have been obtained before and after the precesiation procedure. Residual gas buildup on the filament is monitored by closing the tube isolation valve for a period of

time, then opening the valve and flashing the filament while monitoring the gas of interest. Methane data were obtained simply by monitoring the mass 15 peak while opening the isolation valve, since flashing the filament cracks any methane present on the filament.

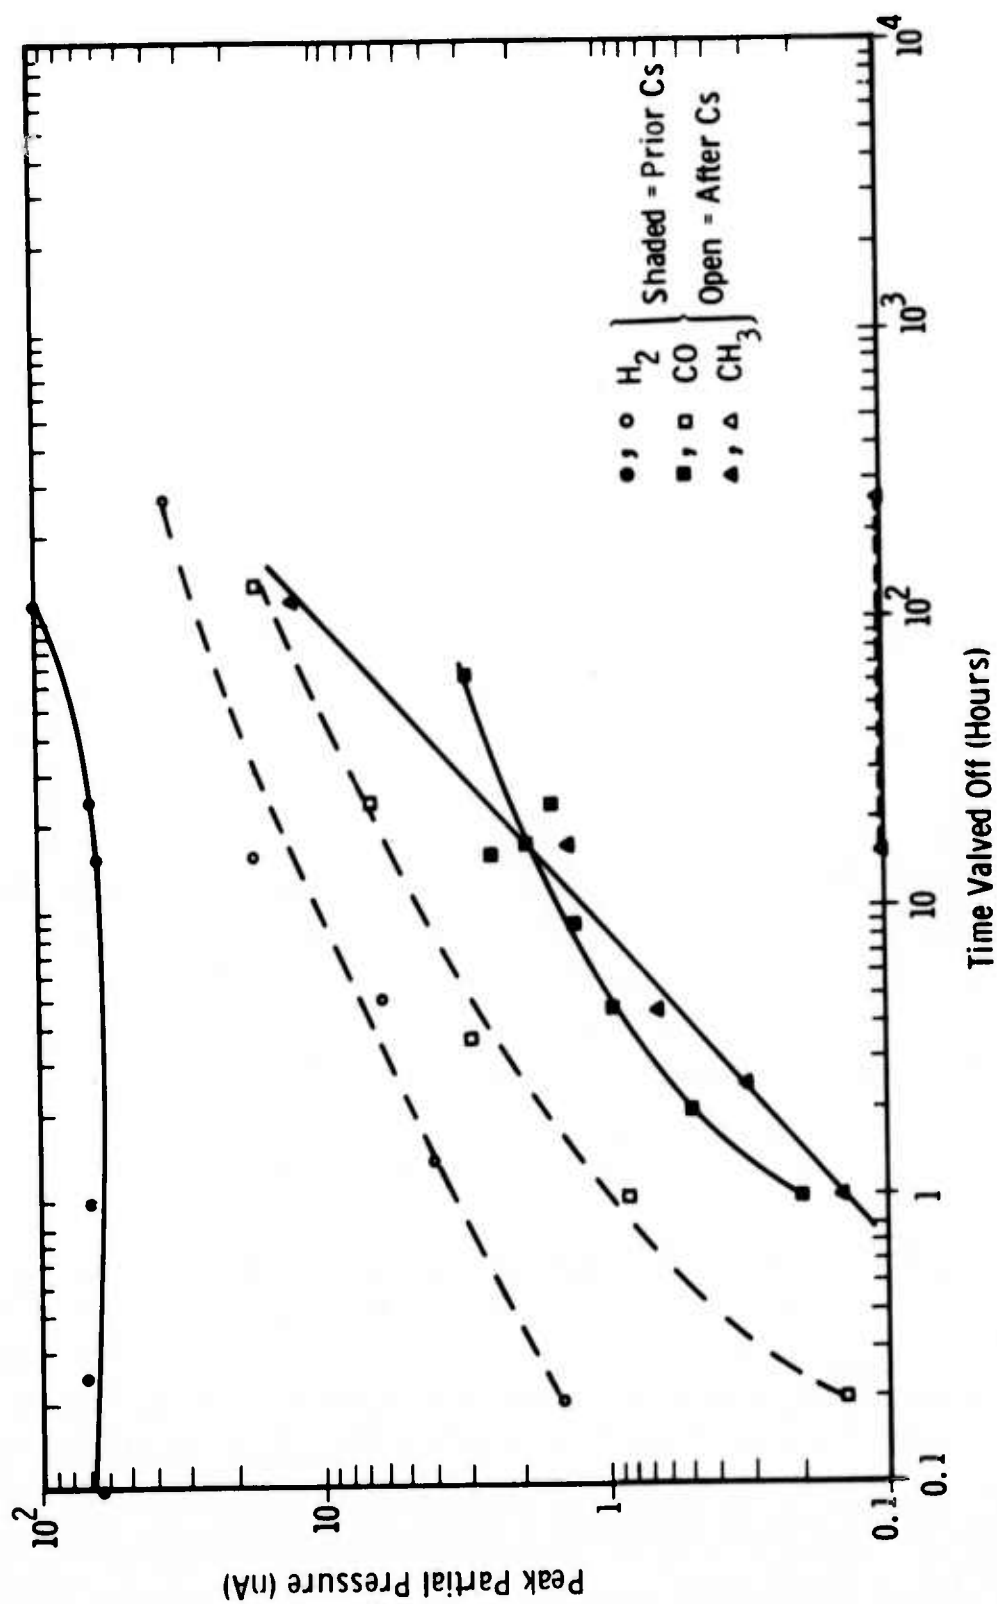
Figure 13. Results obtained in flash-filament experiment.

Prior to cesiating the tube, the prominent residual gases observed after the valve had been closed for a few days were  $H_2$ , CO, and  $CH_4$ . The system pressure also increased momentarily to  $\sim 5 \times 10^{-9}$  torr when the isolation valve was opened. After cesiating the tube the prominent gases were  $H_2$  and CO. The efficiency of Cs as a getter was apparent in that pressure increases of only  $\sim 10^{-10}$  torr were observed upon opening the isolation valve. Peak partial pressures observed when the filament was flashed are shown in Fig. 13. Cesium apparently getters methane at a very high rate, essentially eliminating it as a residual gas. Calculations indicate that 30 nA represents roughly one monolayer (an accurate calibration will be obtained when the experiment is completed). Experimentally, the effect that various gases have on the sensitivity of the III-V photocathodes is known--see Table I. On the basis of the previously-measured sensitivity of the quaternary to  $H_2$  and CO, it is difficult to interpret the results of the present experiment. From the results presented in Fig. 13 and Table I, one would expect image tubes with quaternary cathodes to die irreversible in a few hundred hours and, as discussed in Sec. 2.1.3.1, this is clearly not the case.

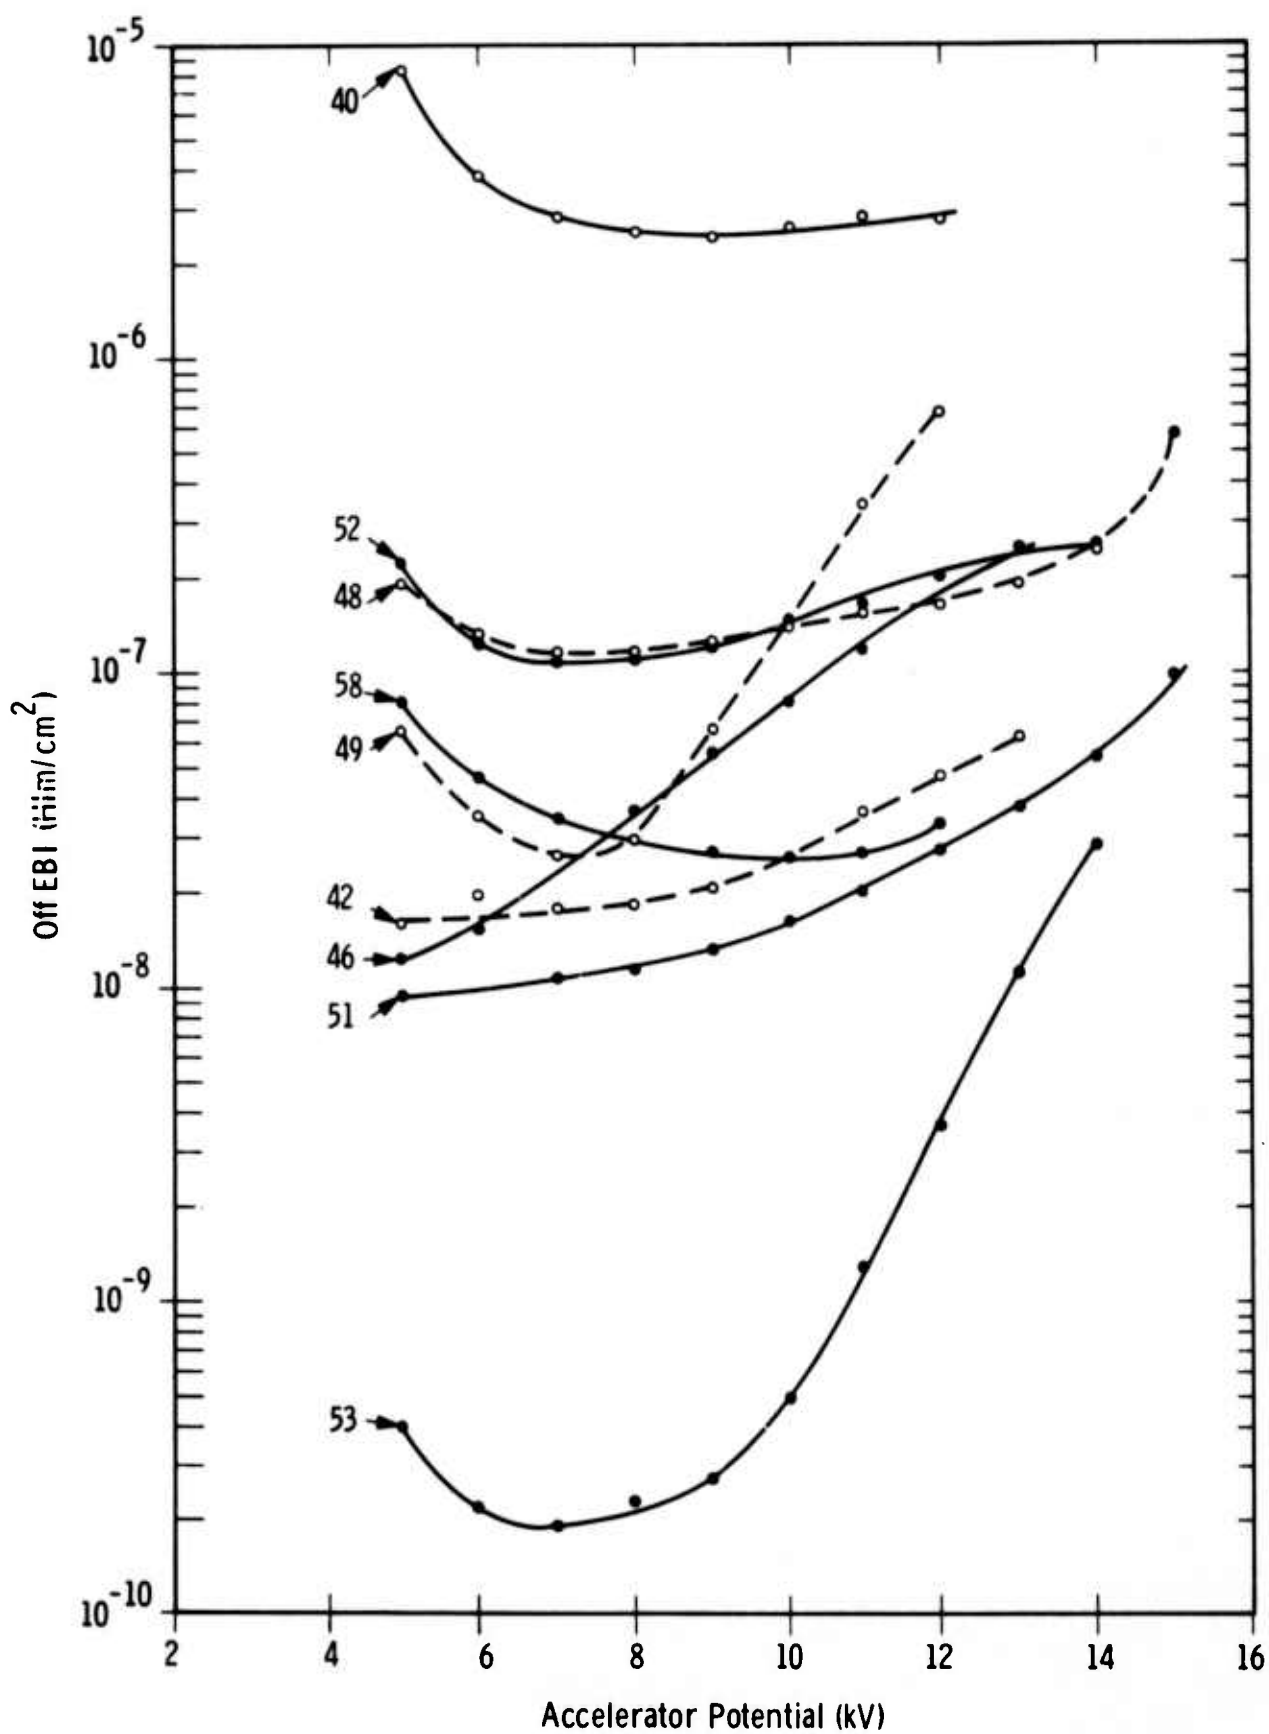
Figure 14. Background in the gated-off mode (focus electrode at -2 kV) vs accelerator potential for several inverter tubes with InGaAsP cathodes.

In the previous quarterly report, field emission from the gate was reported to be the mechanism responsible for limiting the background in the gated-off mode (focus electrode at  $\sim -2$  kV). During this quarter several tubes were tested in the OFF mode and the results are presented in Fig. 14. The variation in magnitude and shape of the curves obviously indicates that the simple field-emission mechanism is not the complete story. This is not believed to be a serious problem but techniques will be considered for minimizing the OFF background.
